CONNECTICUT RIVER BASIN
CLAREMONT, NEW HAMPSHIRE

CLAREMONT PAPER COMPANY DAM
NH 00139

PHASE I INSPECTION REPORT
NATIONAL DAM INSPECTION PROGRAM

FEBRUARY 1979

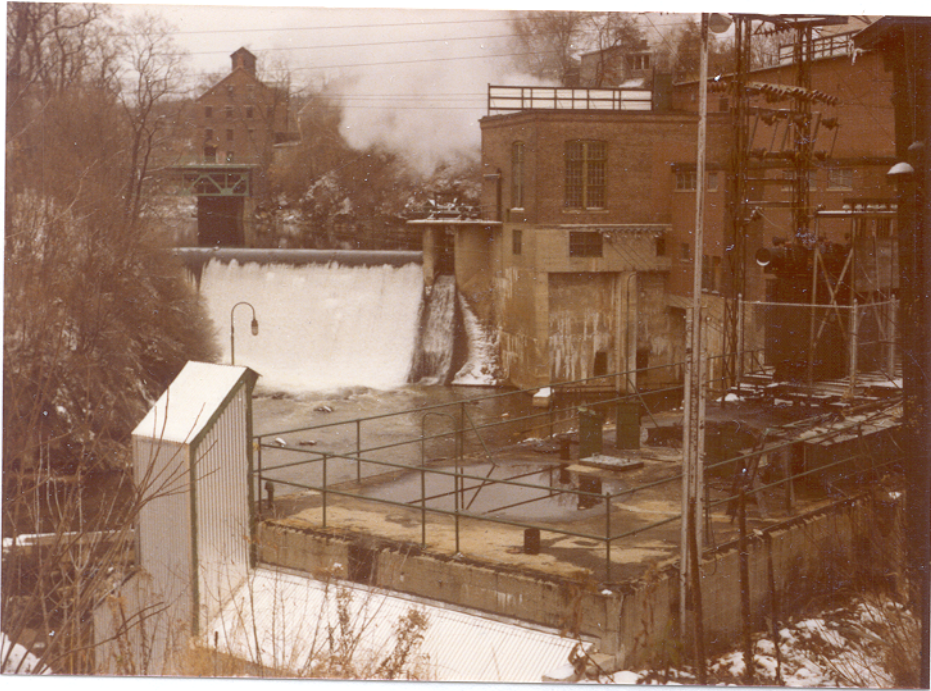
b. Dam. Claremont Paper Company Dam is a concrete gravity dam 145 feet in total length with an ogee downstream face, about 34 feet high, 28 feet wide at the base, and 91 feet long at the crest. (See Appendix C - Figure 2.) At the time of the inspection, several inches of water were flowing over the crest of the dam. (See Appendix C - Figure 3.) To the extent that the downstream face of the dam was visible beneath the overflowing water, no obvious defects were observed in the concrete. Drawings of the dam show that the upstream face is nearly vertical, but could not be verified from the visual inspection because of the water flowing over the dam. Recent photos in the Claremont Paper files of the upstream face taken when the dam was drained do not indicate any obvious defects.

the structure to be in good condition. The powerhouse contains two 400 KW capacity generators with vertical axis turbines which were operational and in good condition. Some efflorescence was observed from a distance on the downstream face of the powerhouse building in the vicinity of the wheel pits. (See Appendix C - Figure 2.) Because of the inaccessibility, detailed close-up field inspection of the downstream face could not be accomplished.

Figure 2 - Looking northeast at the downstream face of the dam and power house.

Some concrete spalling was observed around the gate structures at the south end of the dam and some efflorescence was observed on downstream face of the power house. The spalling and efflorescence do not pose any immediate problems, but should be repaired as part of the routine maintenance program.

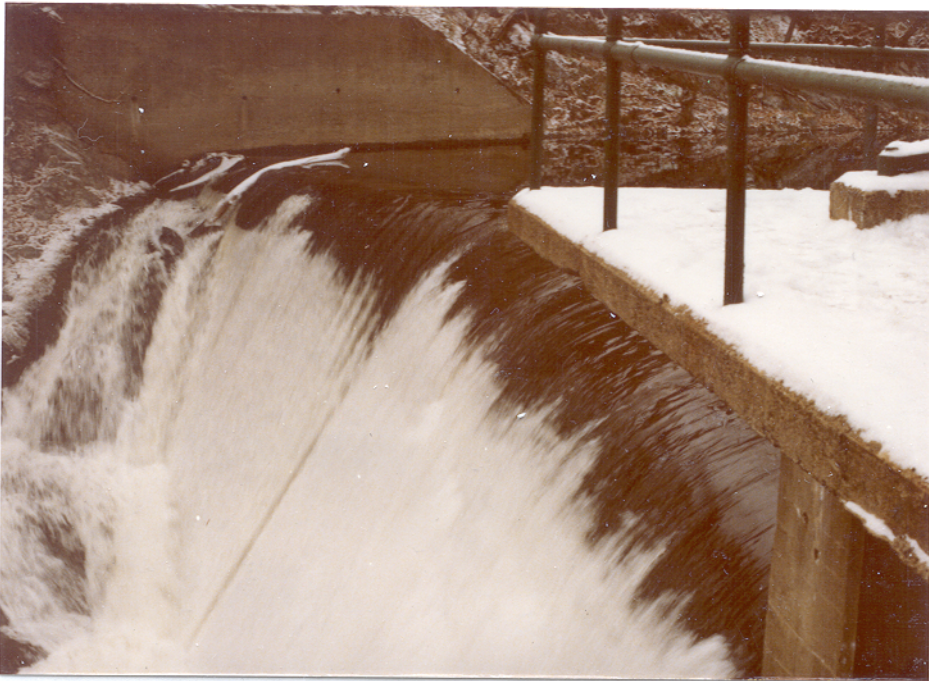
Figure 3 - Looking northwest across the concrete ogee weir from the service bridge.

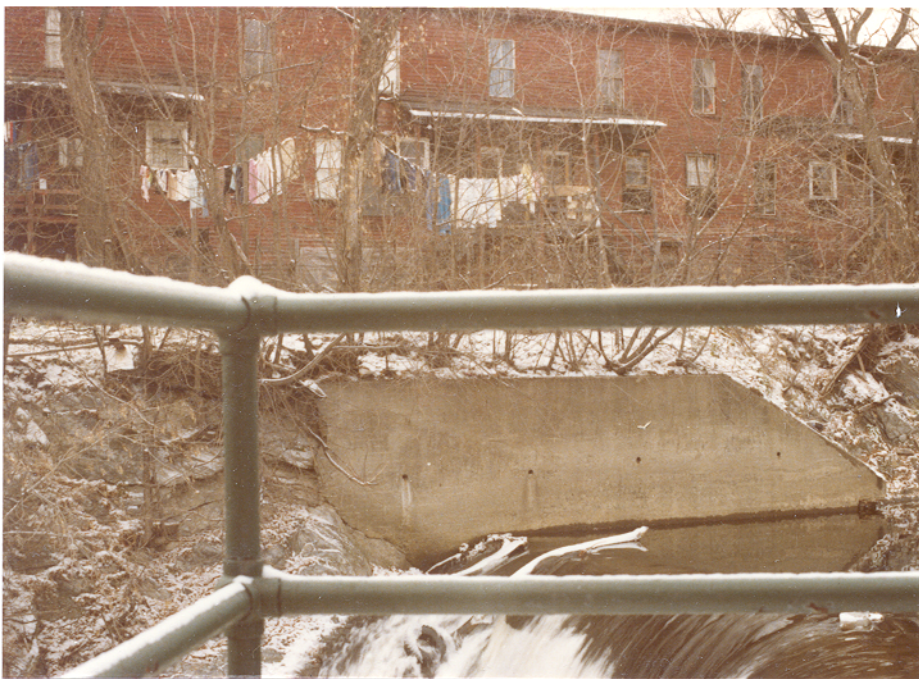
The dam is located at the downstream end of a rock gorge about 150 feet wide at reservoir level. The surface of the rock in the vicinity of the northwest abutment is estimated to slope at about 45° toward the reservoir on the basis of visual observation from the south abutment. The rock appears to be foliated and the exposed rock surface appears to have developed along the foliations. A vertical concrete wall founded on bedrock has been constructed at the northwest abutment perpendicular to the axis of the dam. The wall has a total length of 42 feet (scaled from a drawing of the dam), extending from about 10 feet downstream of the crest to about 25 feet upstream of the crest. There are four weep holes in the wall at a height of about 4 feet above the crest of the dam, as estimated by visual inspection from the south abutment. No water was

discharging from the weep holes at the time of the inspection, but staining of the concrete below the two weep holes farthest downstream indicate that water has discharged from those weep holes sometime in the past. (See Appendix C - Figure 4.) The concrete in the wall appears to be in good condition. That part of the abutment which was visible above the water surface appeared to be in good condition.

Figure 4 - Looking at the four weep holes in the northwest abutment of the dam. Note housing adjacent to the abutment.

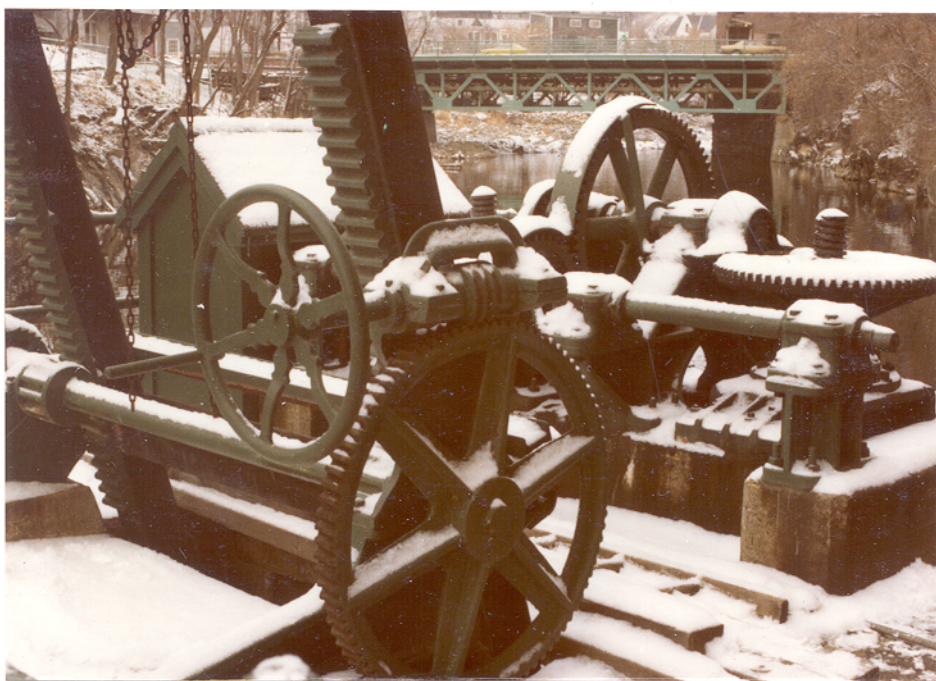
(2) Concrete Service Bridge. The concrete service bridge, which supports the gate operating mechanisms for the trash gate and low-level sluice outlet, was observed to be in good condition. The support piers at the water level revealed some surface deterioration to a maximum depth of three inches. The railings appear in good condition with no evidence of significant corrosion.

The gate mechanisms were covered with ice and snow but appeared to be in good condition. (See Appendix C - Figure 5.) The trash gate is mechanically operated by a wheel. The low-level sluice gate is electrically operated and the motor was in good condition.

Figure 5 - Looking at the gate mechanisms on the service bridge.

- (1) Repair the spalled concrete on the gate structures.
- (2) Remove the debris that lodges on the crest of the dam.
- (3) Establish a surveillance and warning program to follow in the event of floodflow conditions or imminent dam failure.
- (4) Establish a written operating procedure that would include opening all gates in time of flood events and generate maximum power to assist in passage of flood flows. However, when the flood elevation reaches top of dam (457.5' the head gates should be closed to stop flow to the turbines and cease power generation.
- (5) Have the dam inspected by a Registered Professional Engineer once every two years.
- (6) Make periodic observation of the dam (by owner or his representative) to note any changes of conditions.

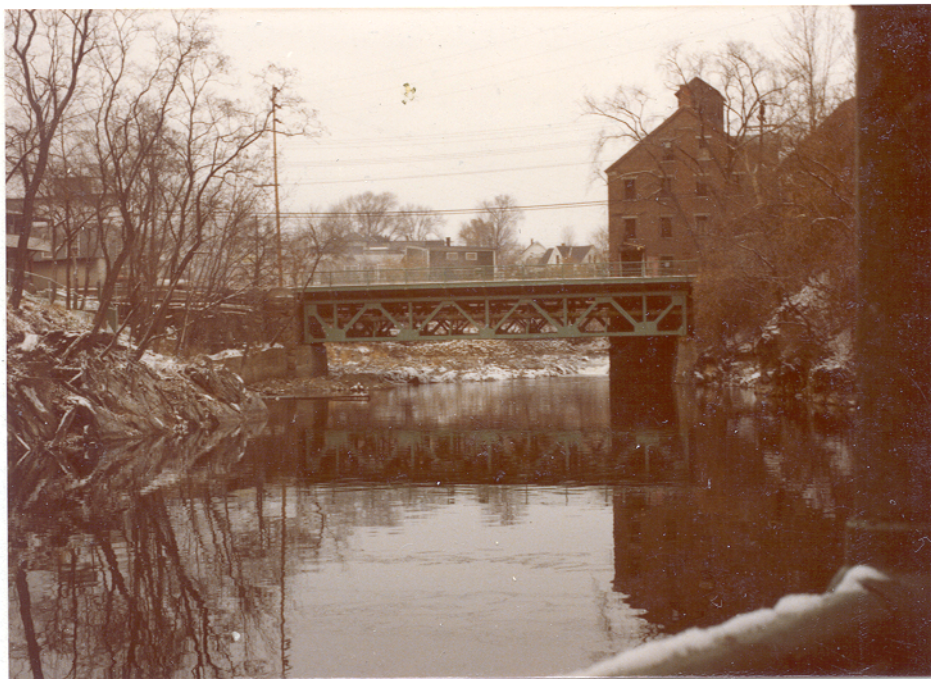
Figure 6 - Looking at the Main Street crossing located approximately 450 feet upstream of the dam.

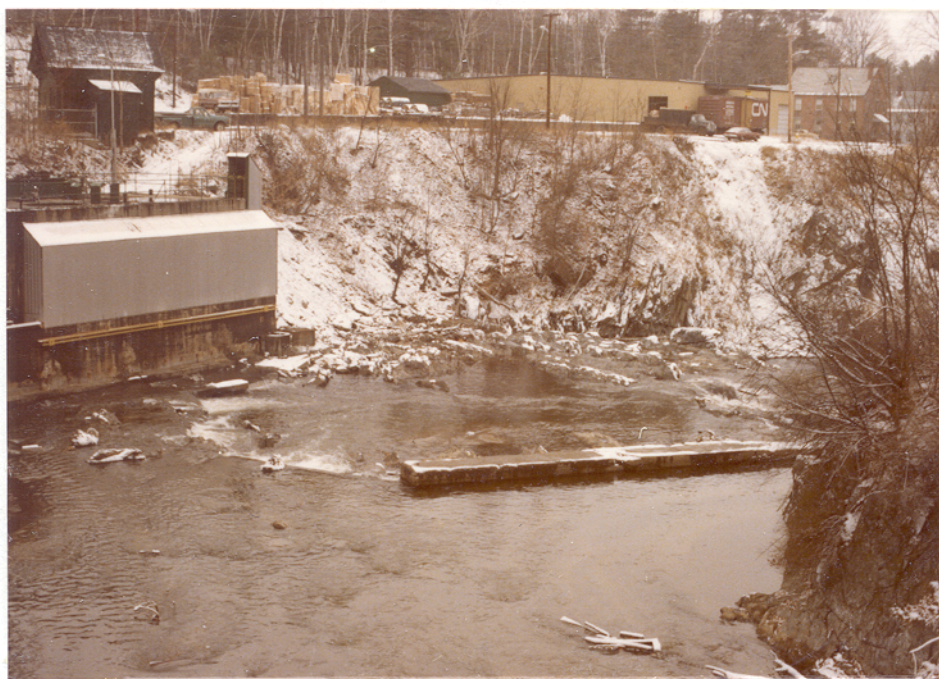
Figure 7 - View of the downstream channel from the service bridge.
